**Federal Building and Fire Safety Investigation of the
World Trade Center Disaster**

Maintenance and Modifications to Structural Systems

David A. Fanella
Arnaldo T. Derecho
S. K. Ghosh

September 2005

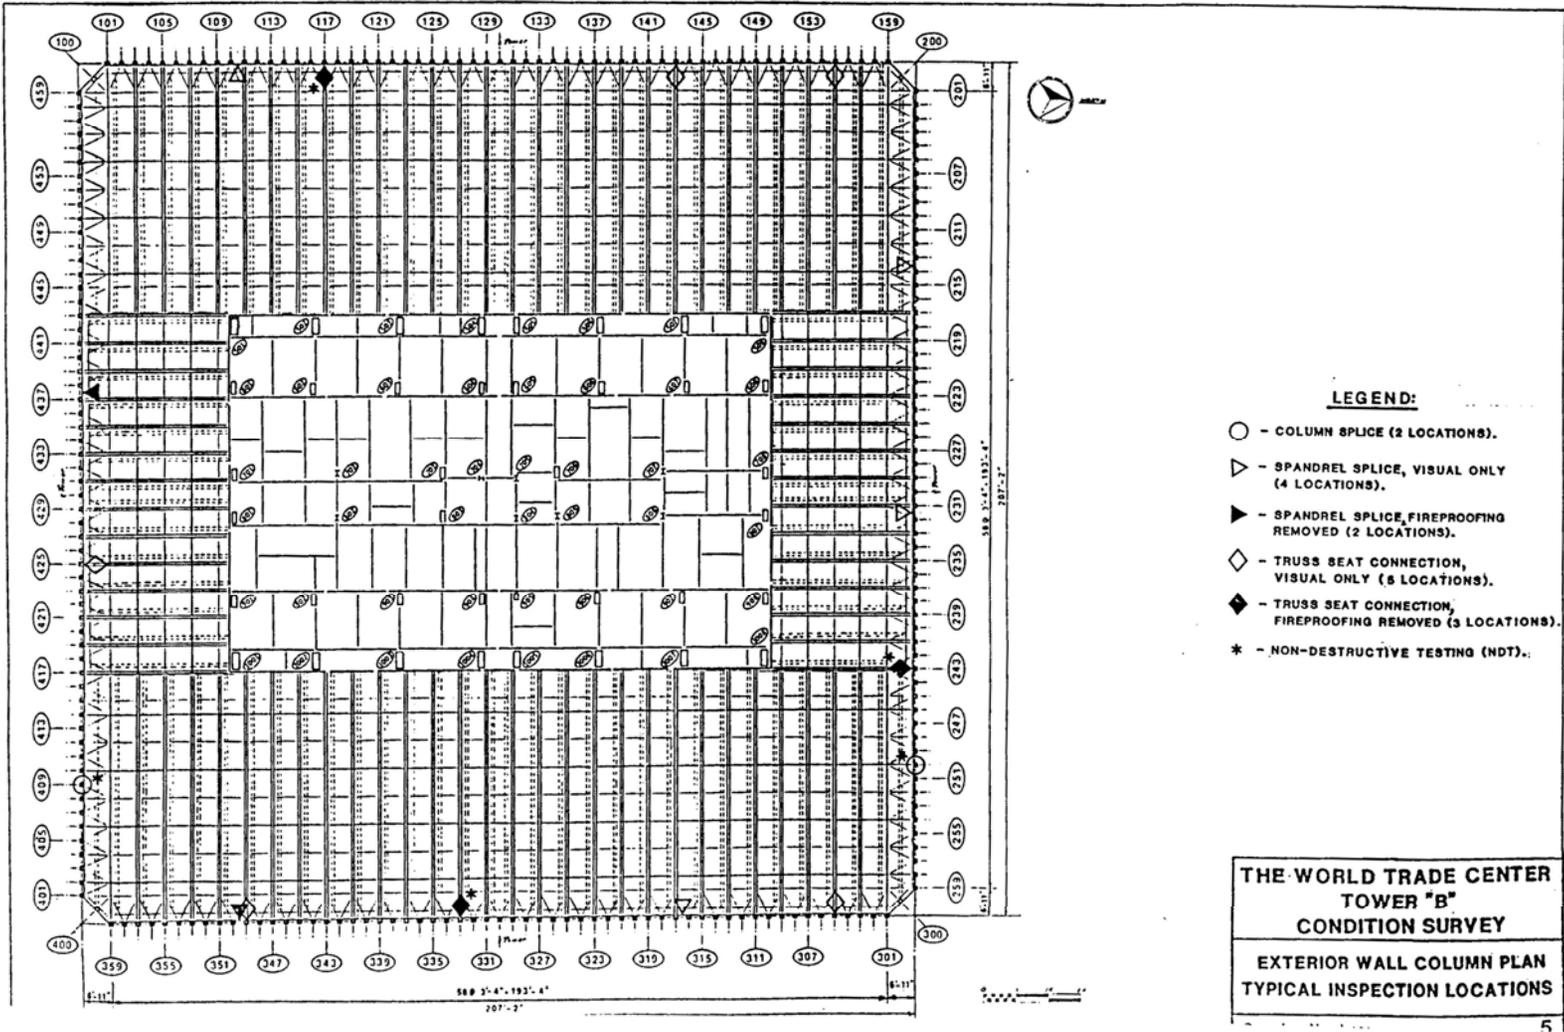
Figure 3-1. Typical inspection locations of exterior wall per 1990 Condition Survey Report of WTC 2.

Inspection of the exterior walls was made from inside the building. Inspection locations are indicated in Fig. 3–1, which is Drawing 5 from the report (PANYNJ 1990).

Recommendations—No priority recommendations for repair were made in the report. It was recommended, however, that a long-term maintenance program be developed and implemented to clean and paint the inside surfaces of the exterior box columns to prevent further corrosion of the structural steel.

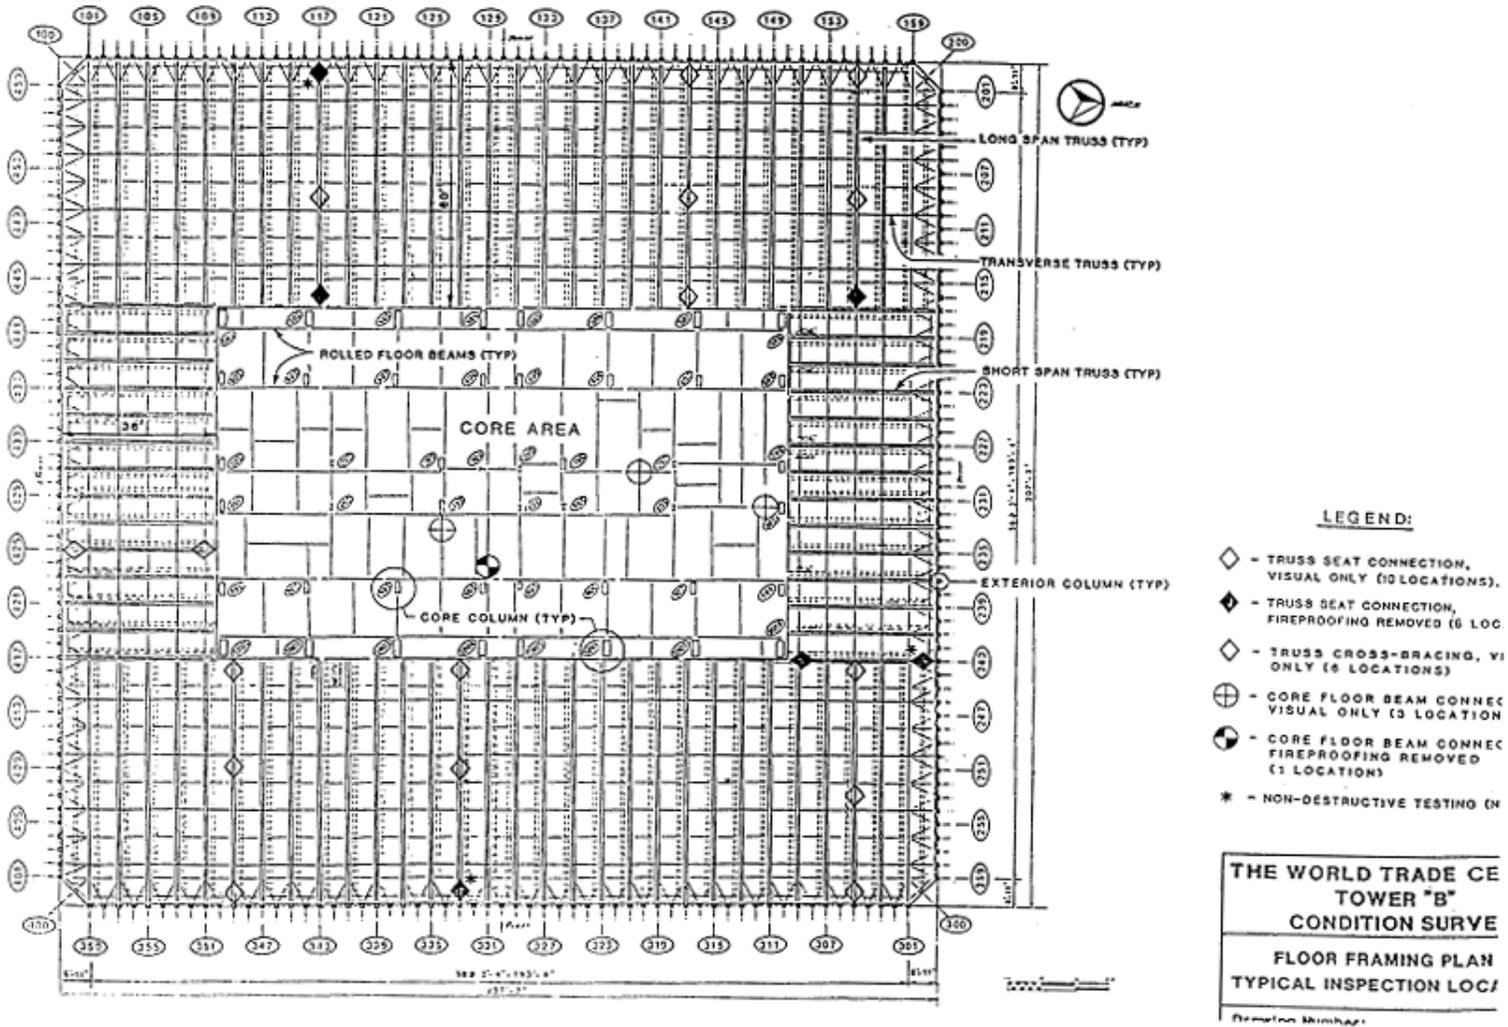
Figure 3-3. Typical inspection locations of floor framing per the 1990 Condition Survey Report of WTC 2.

Floors 9 through 41—Floor framing inspected in this zone was found to be in good condition. Light corrosion was observed on all core beams and beam connections, and on main truss connections on floors 28 and 37.

According to the report, the most significant deficiencies in this zone were found at the damping units (see Table C-1 in the survey report). Damping units on floors 18 and 37 were observed to be missing one fastener at each unit. Two fasteners were found to be missing in one damping unit on floor 29, as well as on floor 38. Also, at floor 38, a damping unit was observed to be missing four fasteners. According to the structural drawings (WSHJ 1967a), four fasteners were required to connect the damping unit to the member attached to the bottom chord of the floor truss, and two fasteners were required to connect the damping unit to the exterior column.

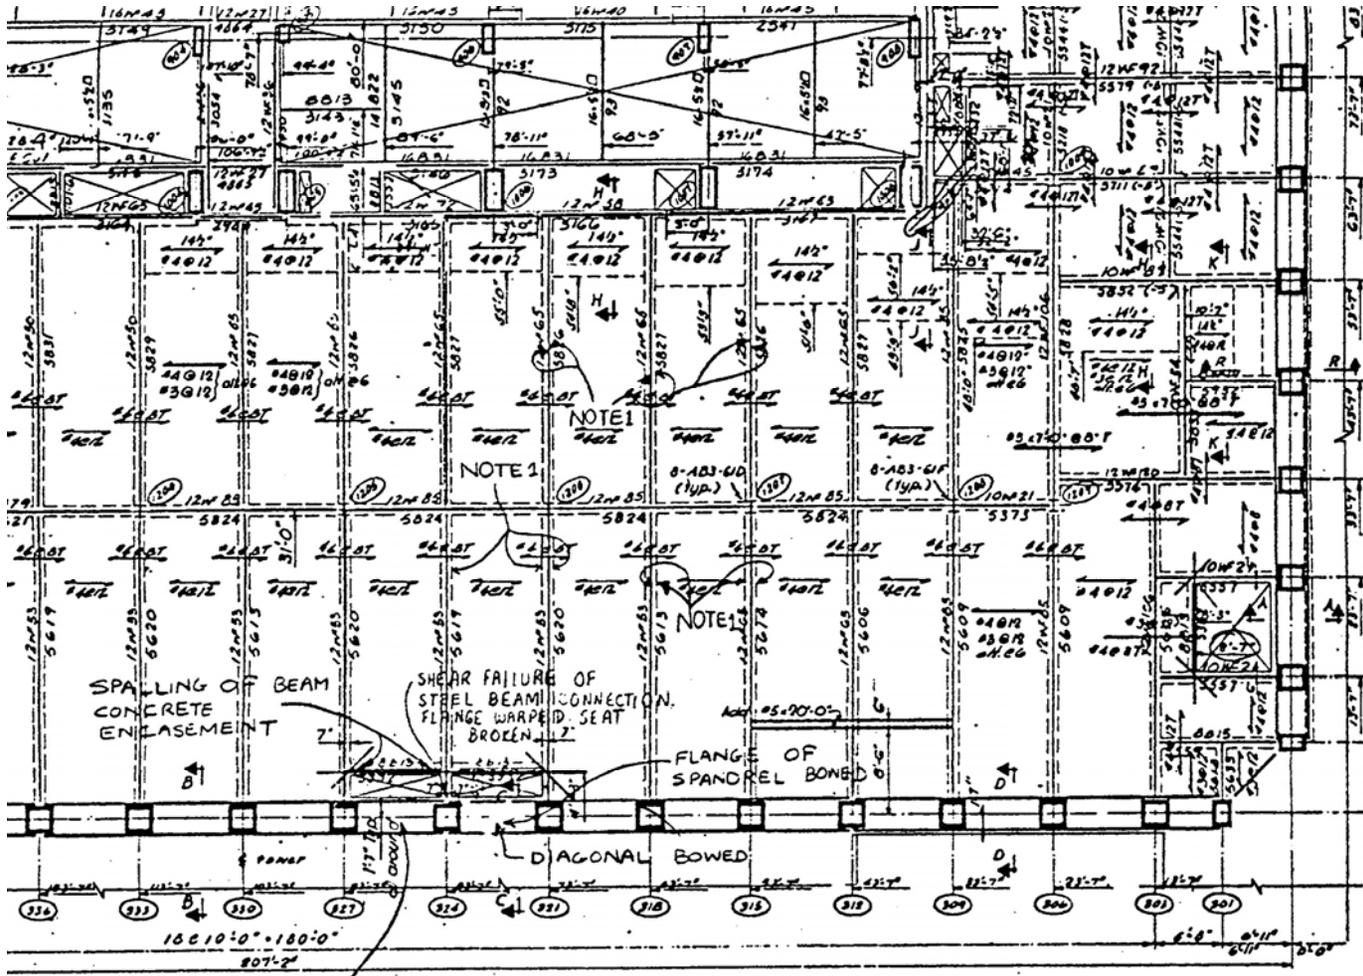
Figure 4-1. Damage assessment for WTC 1 at Level B1.

DIAGONAL MISSING

NOTE 1 → SEPARATION OF SLAB FROM BEAM
CONCRETE ENCASEMENT
