NIST NCSTAR 1-5E

**Federal Building and Fire Safety Investigation of the
World Trade Center Disaster**

Experiments and Modeling of Multiple Workstations Burning in a Compartment

September 2005

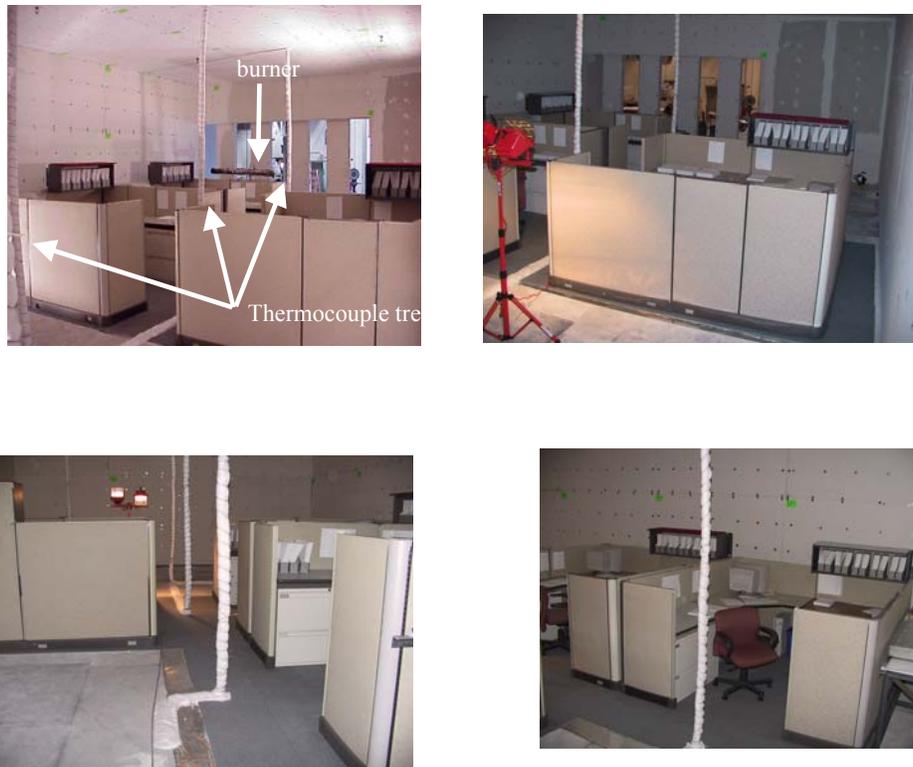
Figure 2-5. Views of interior of test compartment.

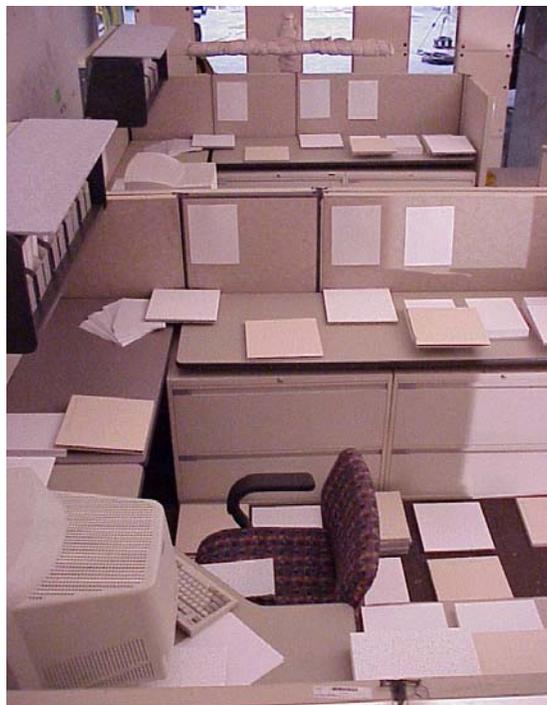
Figure 2-6. Image highlighting the arrangement of ceiling tiles used in Tests 3 and 4. The spray burner and compartment openings are visible towards the rear.

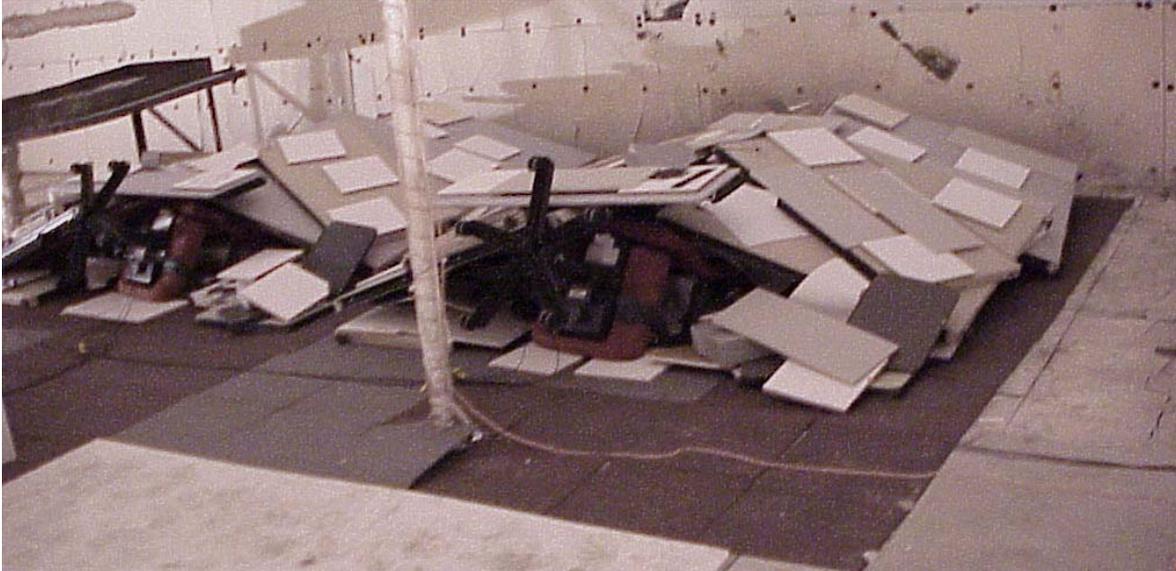
Figure 2-7. The arrangement of “rubblized” Workstations 1 (left) and 2 (right) with ceiling tiles before Test 5. Part of the spray burner is visible on the left.

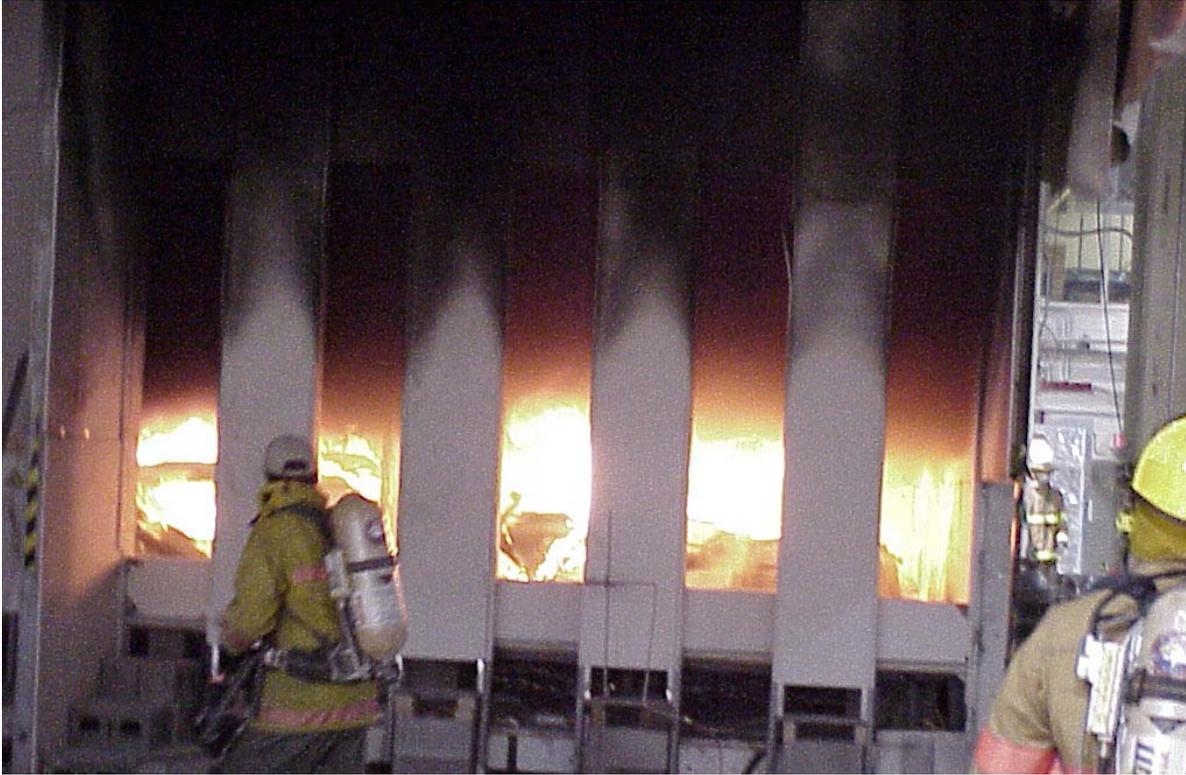
Figure 3–1. View of the fire compartment ½ min after the start of Test 5.

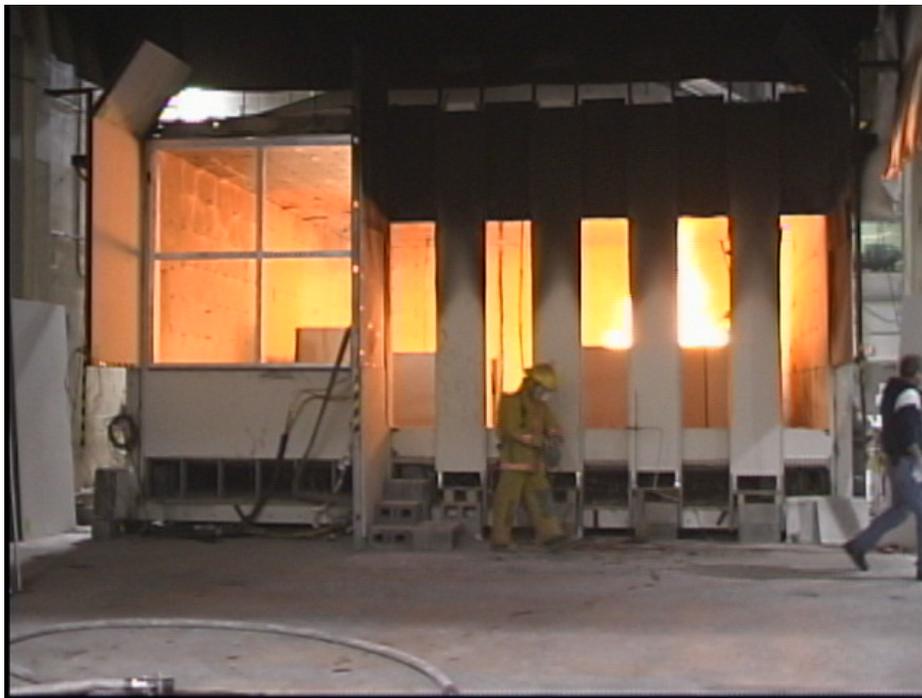
Figure 3–7. View external to the compartment 30 s before ignition of the spray burner in Test 6.

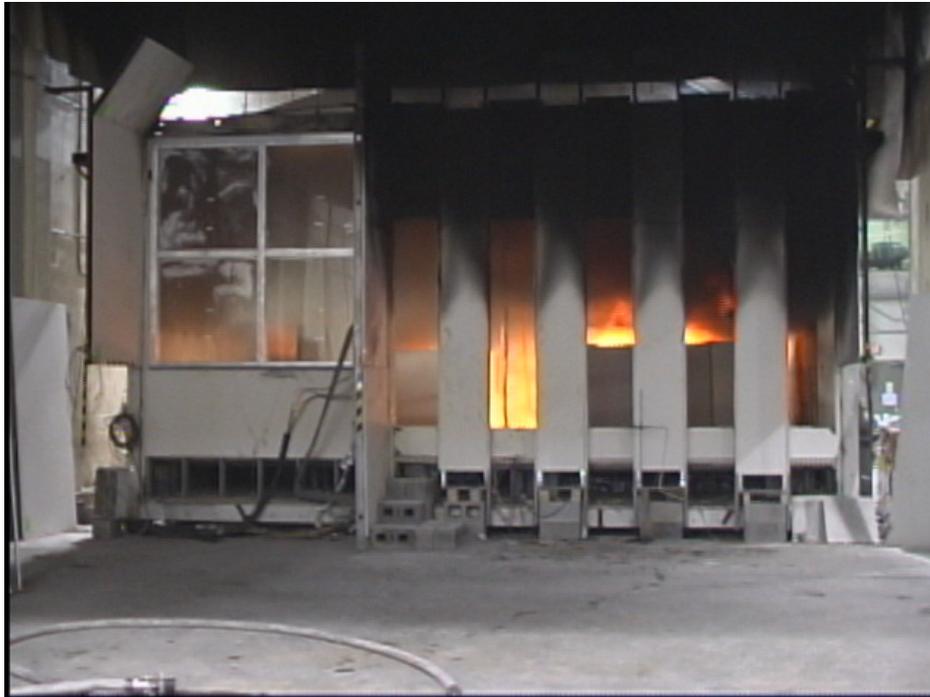
Figure 3–8. View external to the compartment 5 s before ignition of the spray burner in Test 6.

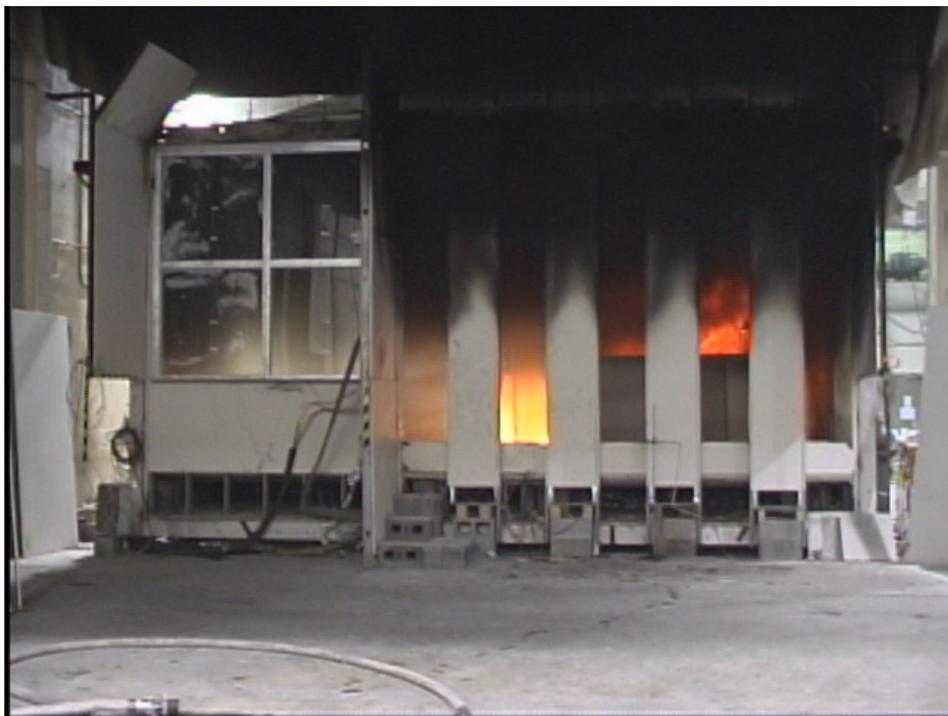
Figure 3–9. View external to the compartment 5 s after ignition of the spray burner in Test 6.

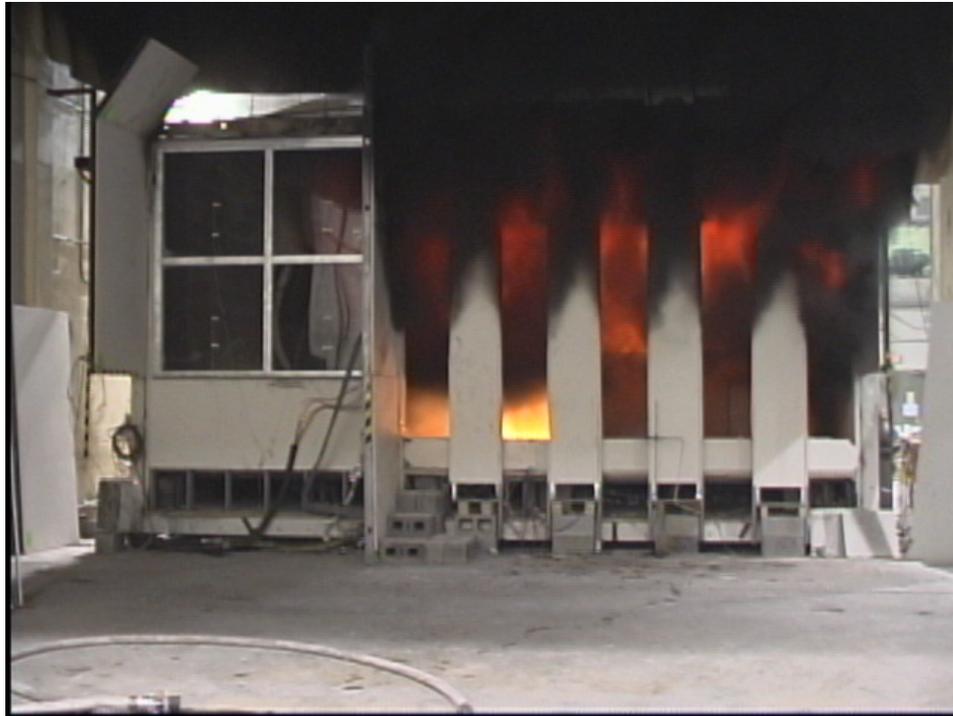
Figure 3–10. View external to the compartment 30 s after ignition of the spray burner in Test 6.

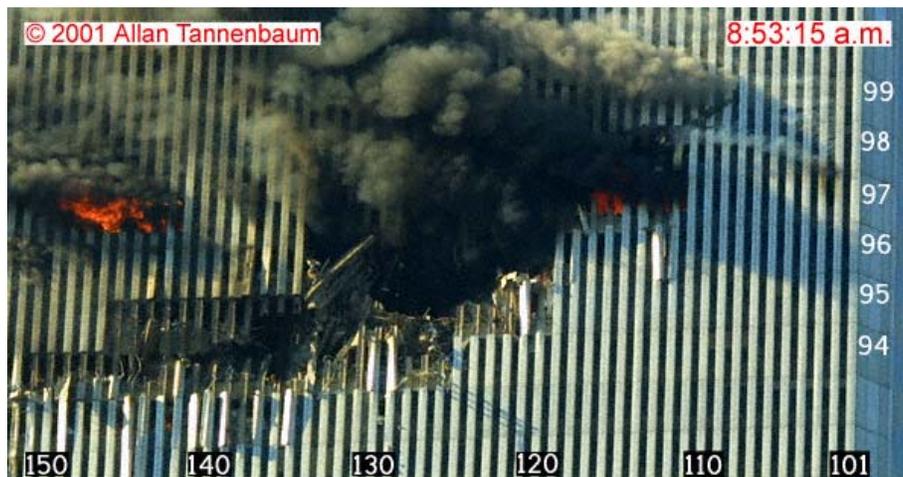
Figure 3–14. Photograph of the north face of WTC 1 recorded at 8:53:15 a.m. on September 11, 2001. Labels showing floor and column numbers were added to the original photograph.
